Schedule B Class Environmental Assessment – Project File Emma Street to Earl Street Pedestrian Bridge

Published: November 21st, 2019

Updated: August 10th, 2022

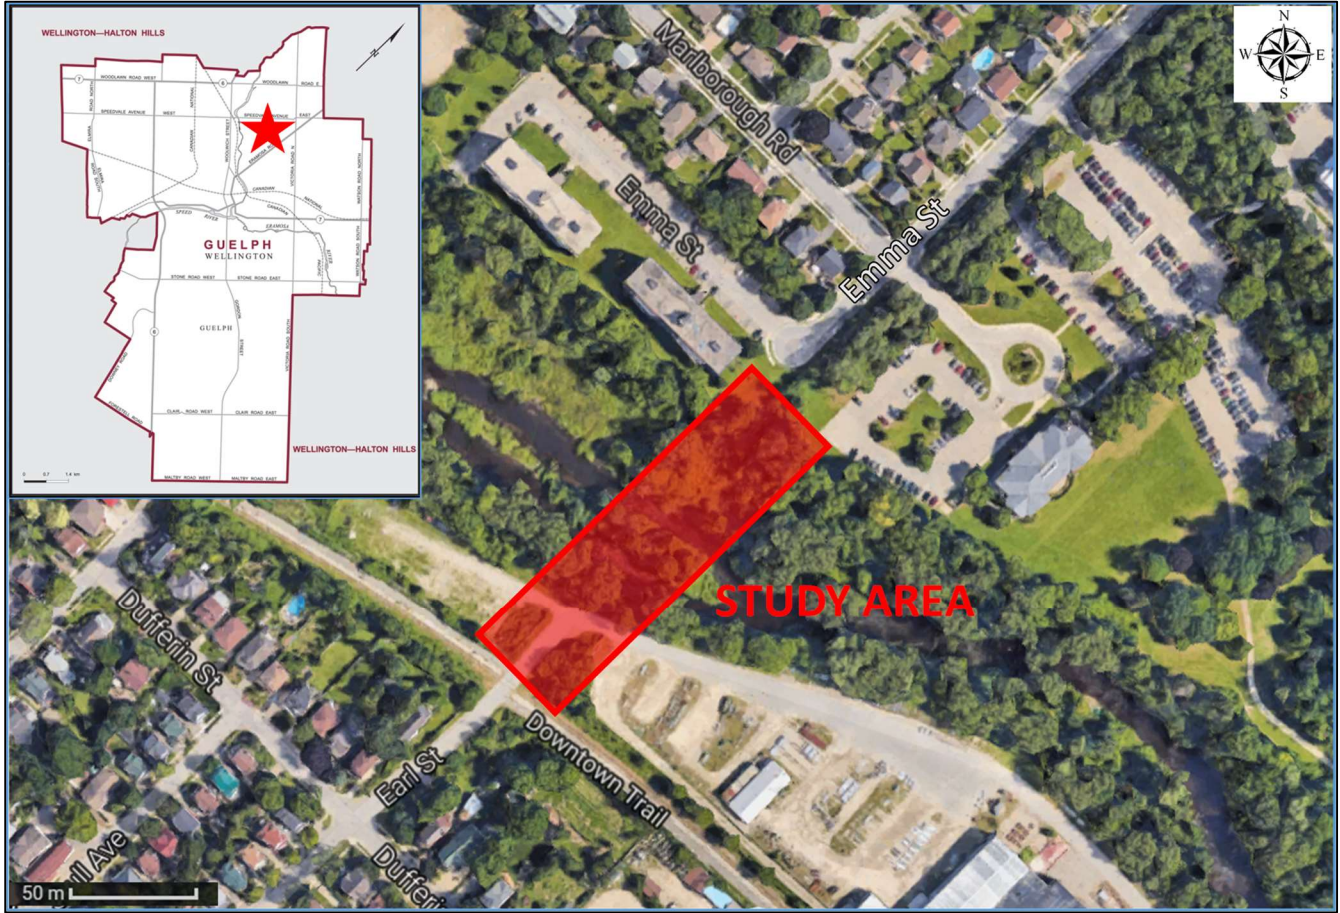
Figure 1-1. Study Area Figure Showing Location of Proposed Bridge Connection.

This Project File is intended to document the Municipal Class EA process to determine if a pedestrian bridge is warranted at this location and, if so, the bridge type and configuration to be constructed. The proposed bridge would connect Emma Street to Earl Street over the Speed River, providing a car-free route for cyclists and pedestrians traveling between downtown and the northeast corner of the city. The proposed location for the pedestrian bridge within the study area is presented in Figure 1-1 below.

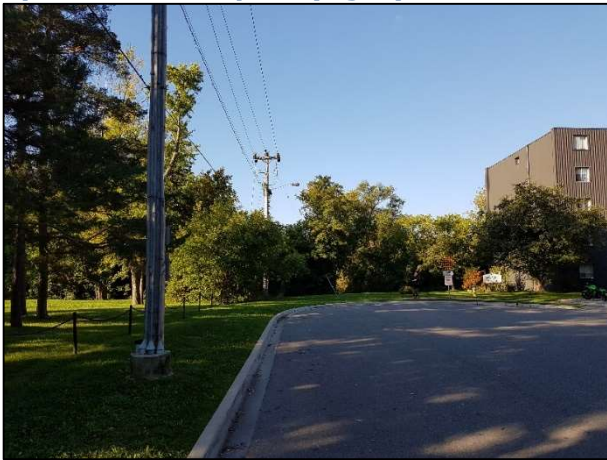
Photo A. Emma Street Towards Vantage Towards Speed River, with Homewood Health Centre (left), and Emma Street Apartment Complex (right).

Select photos have been included below to further illustrate the existing conditions at the ends of Emma and Earl Streets, as well as an as-built drawing of the watermain that was open-cut across the channel in 1962.

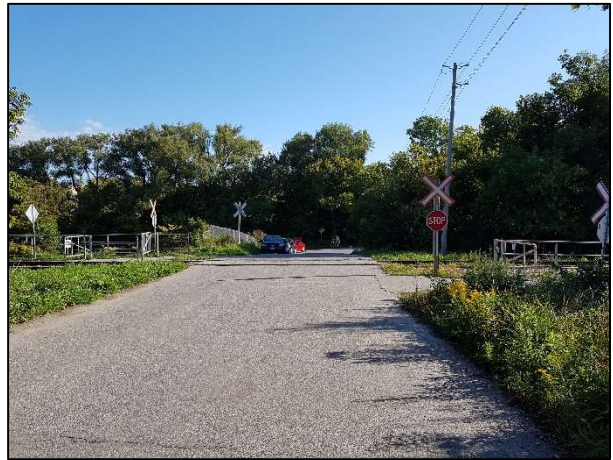
Photo B. Earl Street Vantage Towards Speed River, crossing the Downtown Trail & Railway, followed by Armttec Entrances.

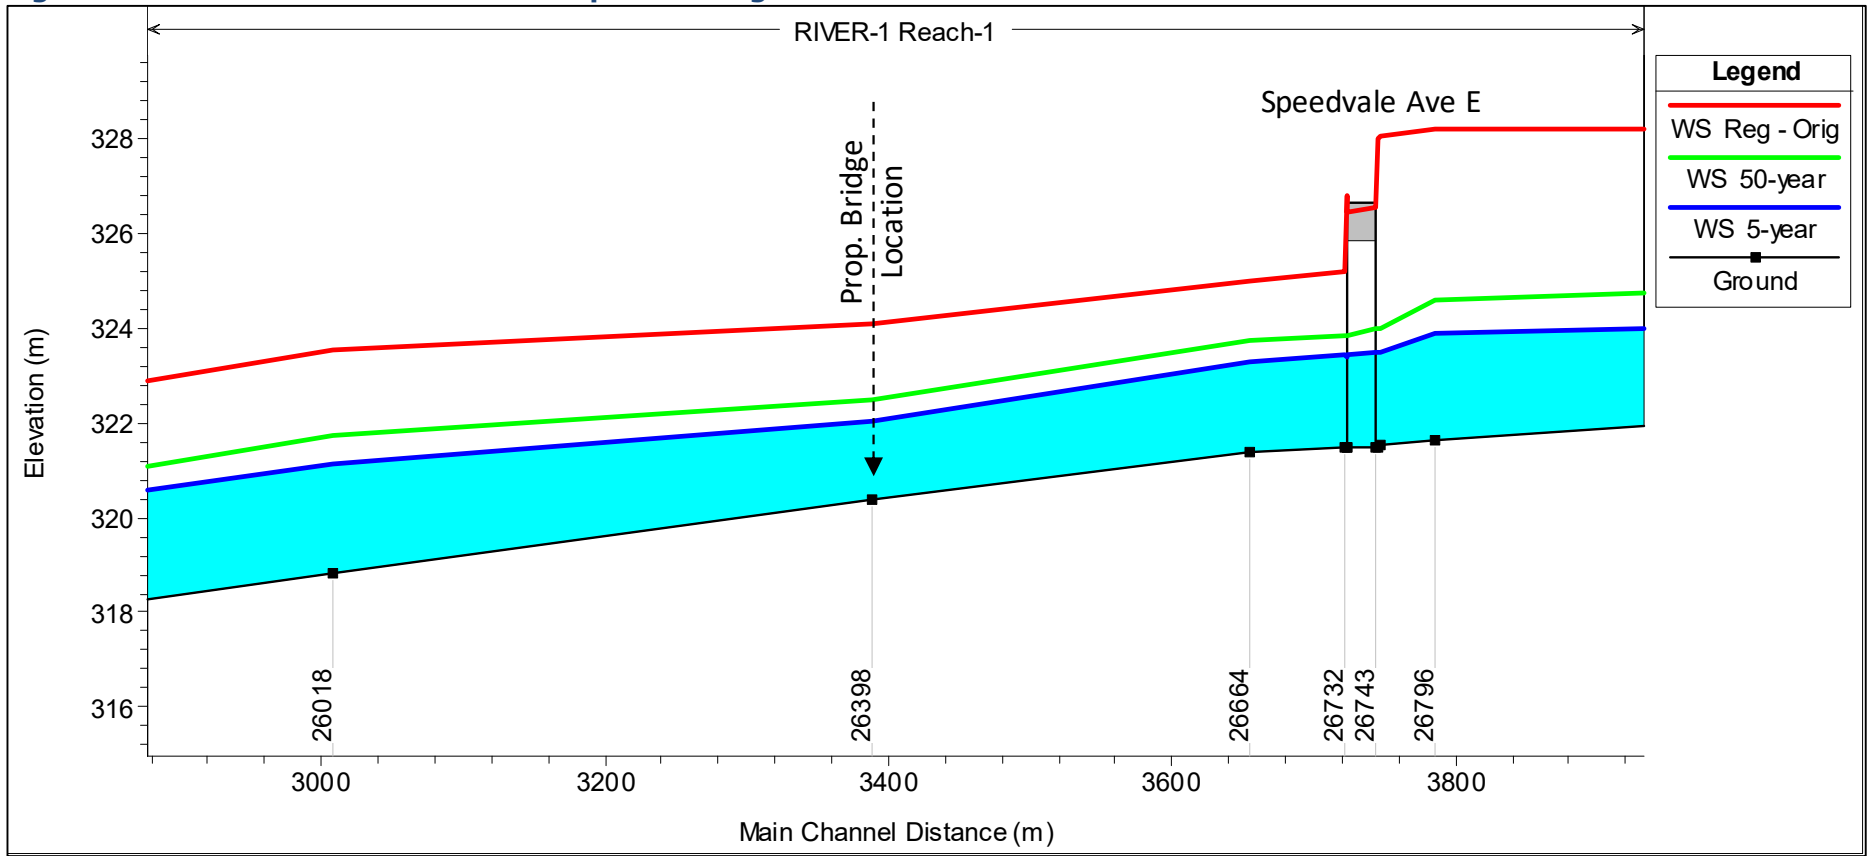
Figure 3-3 Water Surface Profile at Proposed Bridge Location.

The hydraulic results of the existing conditions at RS 26398 are presented in Table 3-3-1 below. A water surface profile plot of the 5-year, 50-year, and Regional flood flows was generated (Figure 3-3). The floodlines and water surface elevations were also plotted on the surveyed planform and cross section (Figure 3-4).

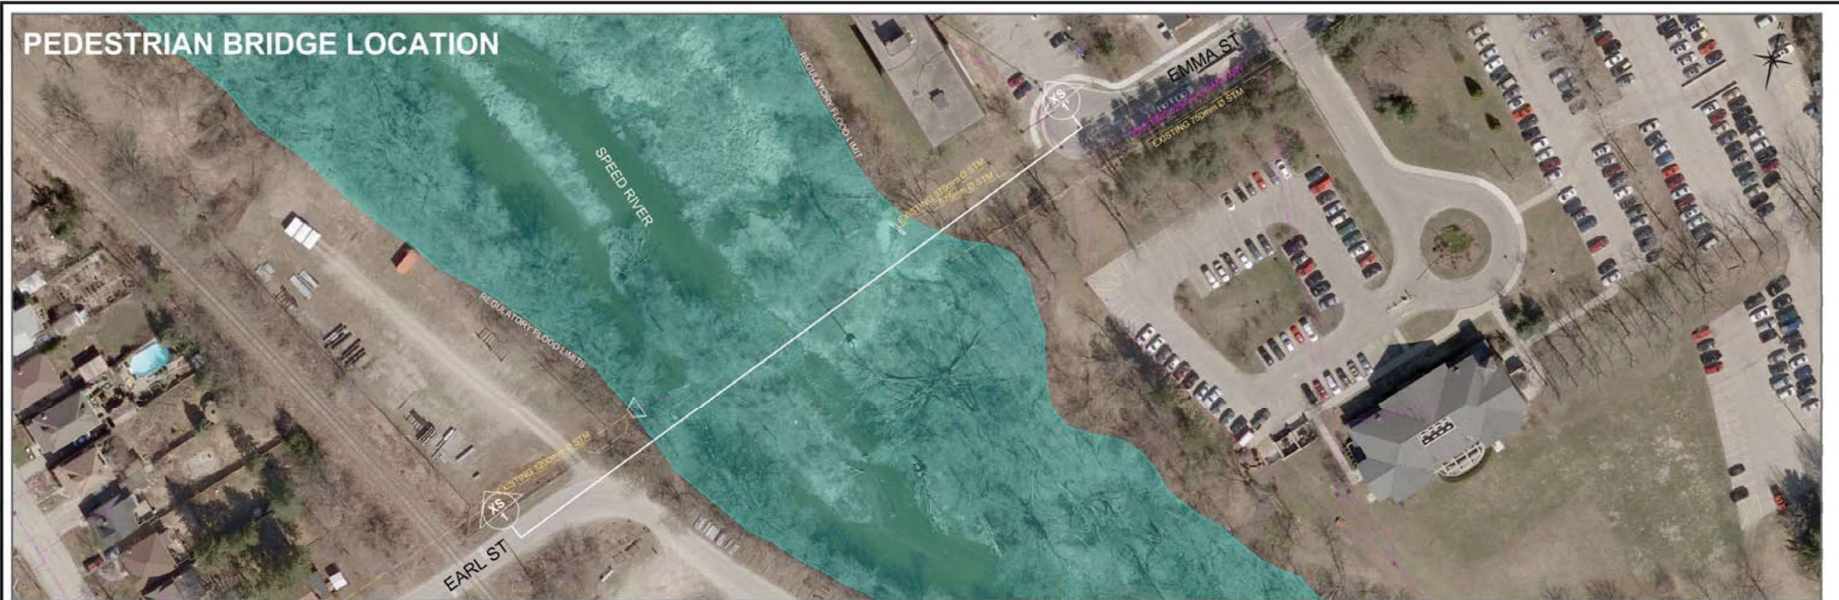
Figure 3-4 Plan & Cross Section Showing HEC-RAS Floodlines and W.S Elevations at the Proposed Bridge Location

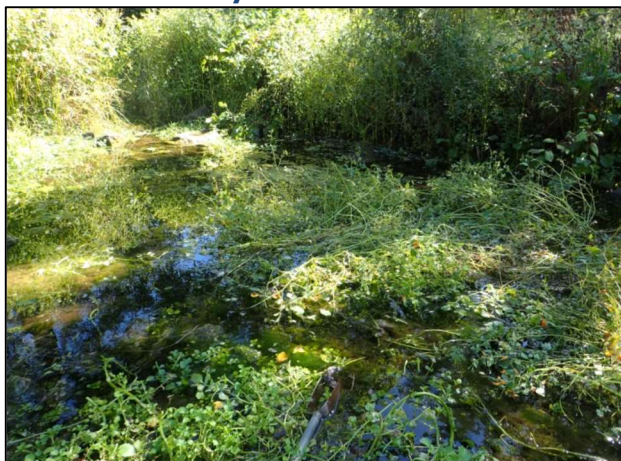
Figure 3-7 Groundwater Seepage Area Along Northern Bank in the Upstream Section of Study Area

An area of groundwater upwelling area (Figure 3-7) was noted along the northern bank of the river, described as a Mineral Shallow Marsh (discussed in Section 3.4.1 and Figure 3-9). This area is low lying, making it more susceptible to flooding, and has soft, wet mineral soil which is less desirable for bridge foundations. The proposed bridge alignment should avoid this area if possible.

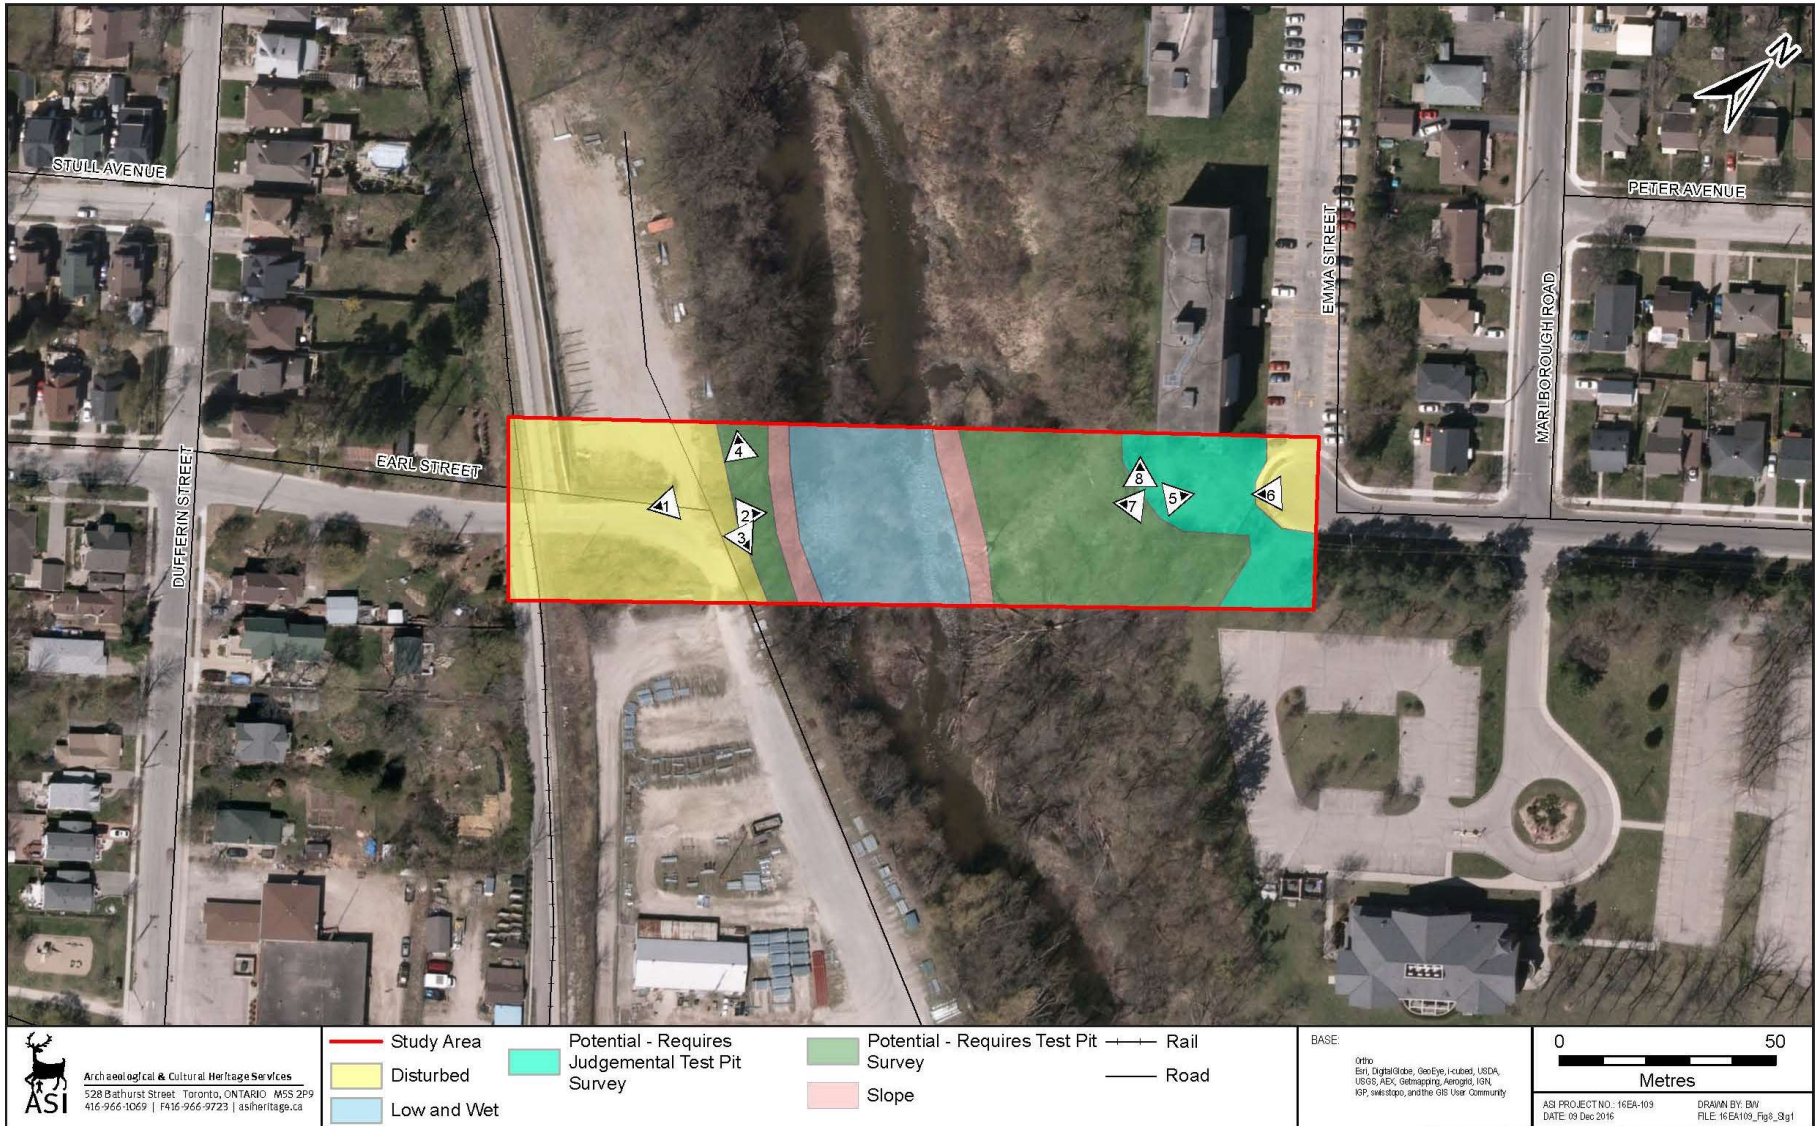
Figure 3-10 Results of Archaeological Property Inspection for Emma St to Earl St Pedestrian Bridge

The property inspection determined that parts of the study area retain archaeological potential (Plates 3, 4 & 7, Figure 3-10) and require Stage 2 archaeological assessment by test pit survey prior to any development.

1. Two previously registered archaeological sites are located within one kilometre of the study area.
2. Parts of the study area possess archaeological potential and require Stage 2 assessment during the detailed design stage, prior to any proposed works.

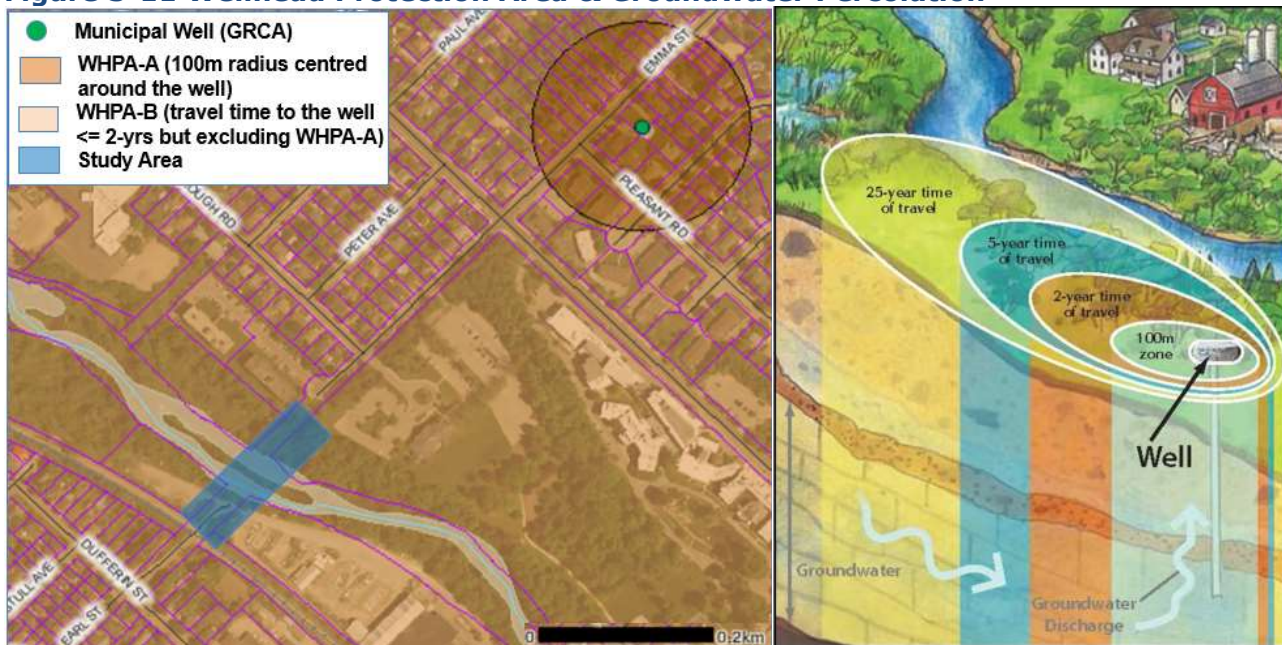
Figure 3-11 Wellhead Protection Area & Groundwater Percolation

Information from the plans show that the groundwater in the study area has been classified as vulnerable and there is a municipal well approximately 400m from the study area (Figure 3-11).
